609TH IRAQI NATIONAL GUARD
BATTALION GARRISON
THI QAR GOVERNORATE, IRAQ

SIGIR PA-06-056
JULY 25, 2006

SUBJECT: Report on Project Assessment of the 609th Iraqi National Guard Garrison,
Thi Qar Governorate, Iraq (Report Number SIGIR-PA-06-056)

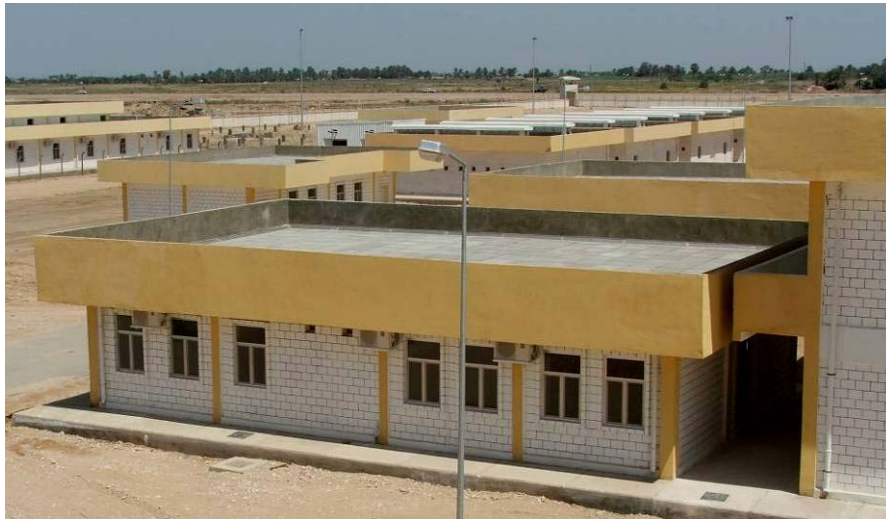
Site Photo 1. Buildings at the 609th ING Battalion Garrison

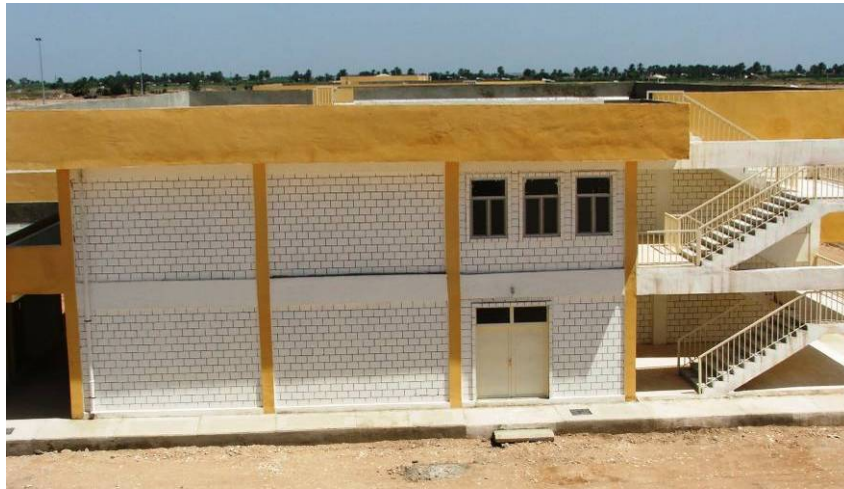
Site Photo 2. Exterior view of one of the three barracks

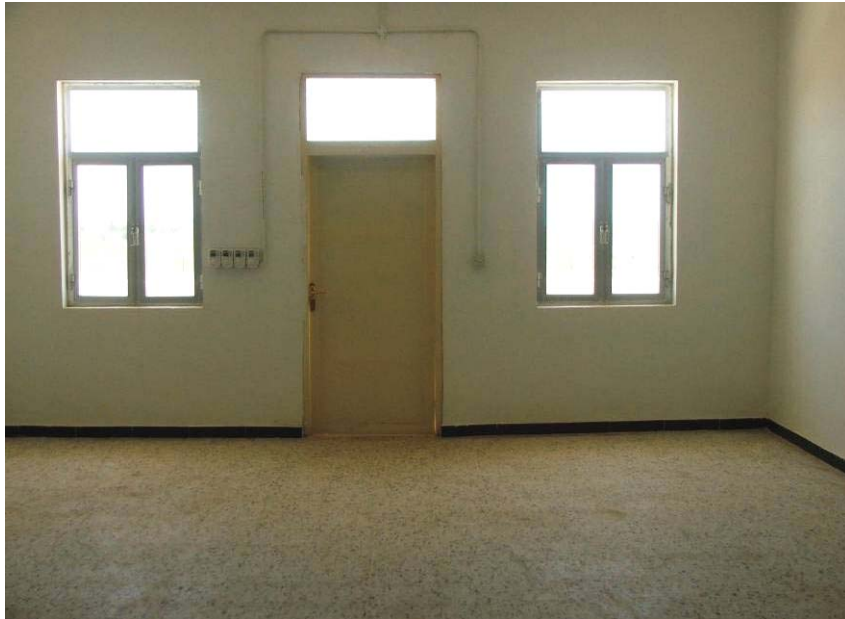
The rooms we inspected were finished in accordance with the design. Each room contained the required number of ceiling fans, lighting fixtures, and controls. The walls and ceilings were plastered and painted, and the flooring finished with terrazzo tile. Doors and windows appeared to be installed properly, although on some of the exterior doors, there were narrow gaps around the door between the door and the frame. We discussed this with the USACE PE, who initiated corrective action to have the contractor install weather stripping and door sweeps. Site Photo 3 provides a representative example of one of the barracks rooms, showing the aluminum windows, one of the exterior metal doors, and the wall mounted lighting and ceiling fan switches.

Site Photo 3. One side of a typical barracks room

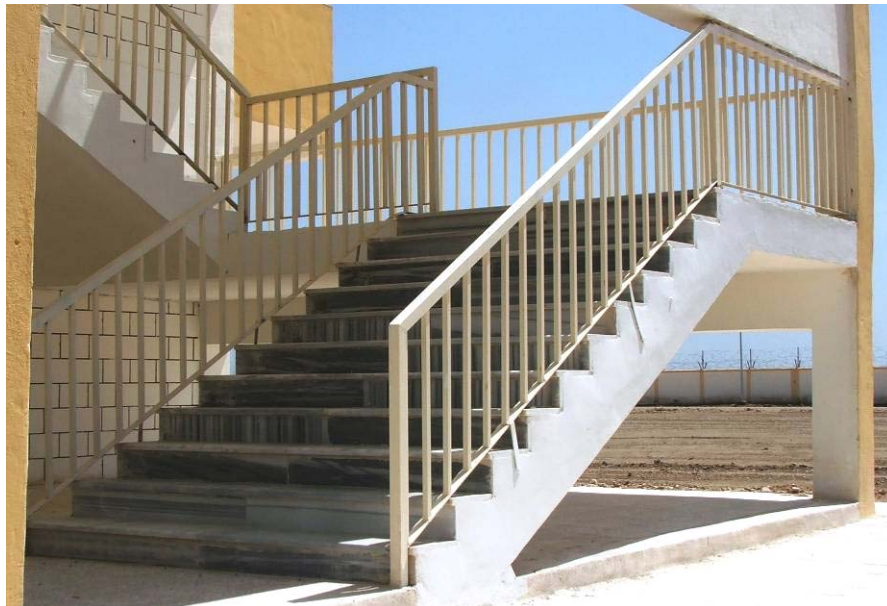
The design for each barracks building required two external stairways to access the second story and the roof. The design called for concrete steps, with no finish to the step other than painting. However, marble tile had been placed as the finish for each step in all six sets of stairs in the three buildings. According to the USACE PE, the contractor installed the marble tile at no additional cost to the Government. Site Photo 4 provides an example of one of the sets of stairs finished with the marble tile.

Site Photo 4. Exterior stairs in the barracks finished with marble tiles

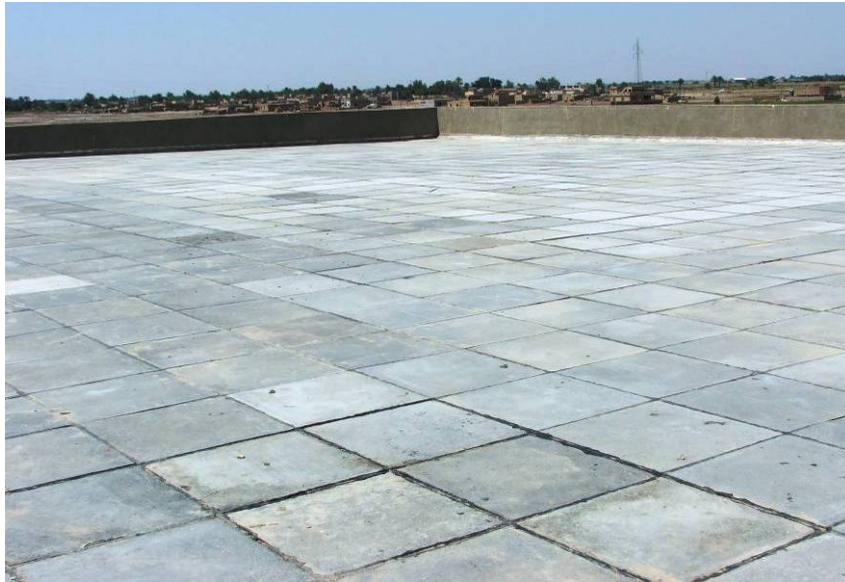
We also inspected the roof of one of the barracks buildings. The roof design for garrison buildings required a built up roof consisting of the reinforced concrete roof slab covered with a waterproofing membrane and thermal insulation board. The design required the insulation board to be covered with a nylon sheet, then with

150 mm of clean soil compacted and sloped for drainage to the roof drains. The surface layer of the roof consisted of 800 millimeter (mm) x 800 mm x 40 mm precast concrete tiles. Based on our observations and a through review of the construction progress photos provided by the USACE PE, we verified the roof of the barracks building was constructed as designed. Site Photo 5 shows the roof system consisting of a top layer of concrete tiles, with sealed joints between the tiles. In addition to the tiles, roof drains (100 mm in diameter) were in place at the corners of the roof as required by the design, and connected to drain pipes hung along the exterior walls.

Site Photo 5. Roof on one of the barracks buildings

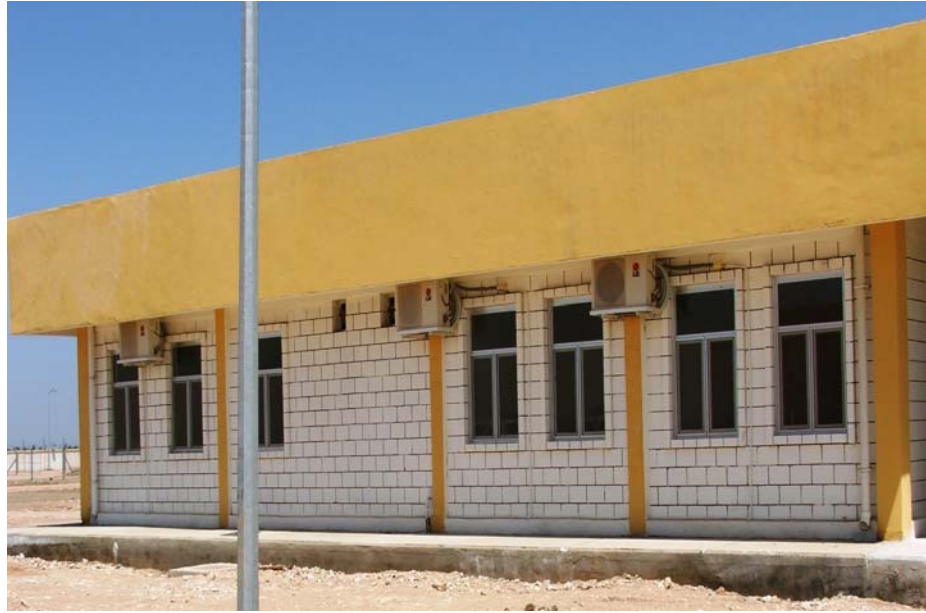
The design also required window HVAC units, although the contractor installed split system units instead of window units after they proposed the substitution at no cost change to the Government. The USACE Resident Office subsequently approved the change. Site Photo 6 shows the exterior of one of the company's headquarters, which includes three of the HVAC condensing units mounted on the exterior wall.

Site Photo 6. Company headquarters building

Based on the review of the design, and our observations on site, the construction of the company headquarters buildings met the requirements of the design.

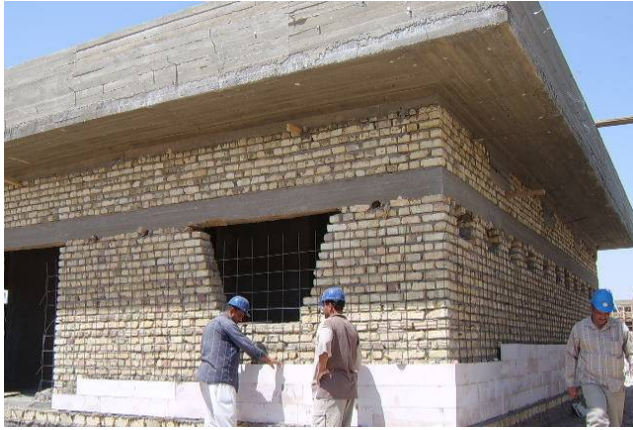
Based on the review of the USACE construction progress photos and our own observations on site, the shower and toilet building exterior walls consisted of a composite wall constructed with an outside veneer of thin limestone block anchored to masonry wall, two brick units thick. The design drawings and specifications did not contain details of this type of composite wall.

Site Photo 7. Shower and toilet building under construction (Photo provided by USACE)

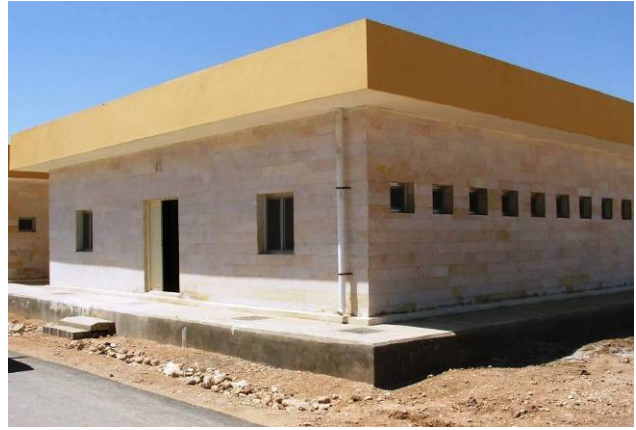
Site Photo 8. Completed shower and toilet building

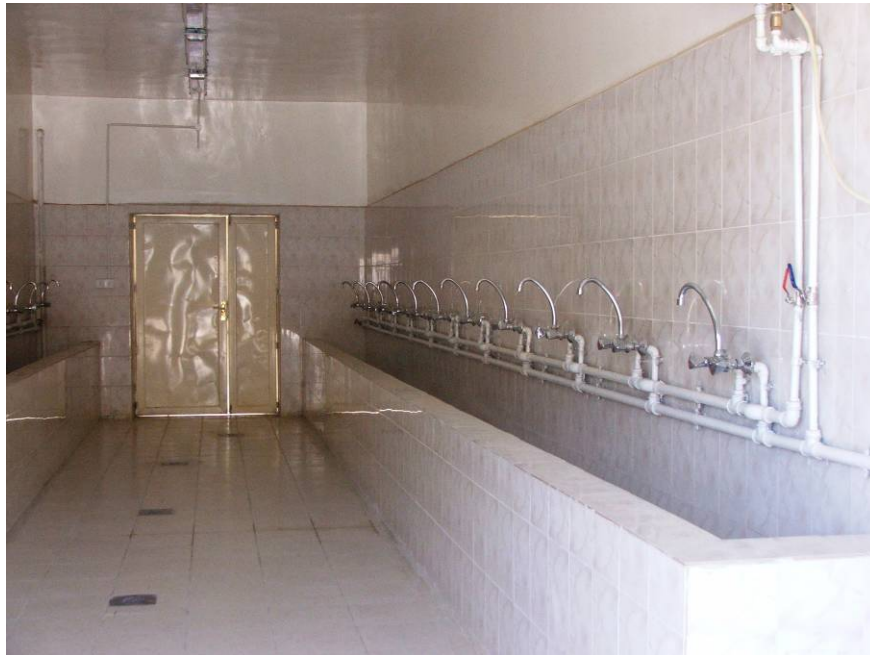
The interior design for each building required 20 water closets with eastern style toilets, 20 individual shower stalls, and 28 hand washing stations. The interior finishes included ceramic tile floors and walls. The design also required individual wood doors for each water closet and shower stall. Site Photo 9 provides an example of the hand washing stations in one of the shower and toilet buildings.

Site Photo 9. Hand washing station in one of the shower and toilet buildings

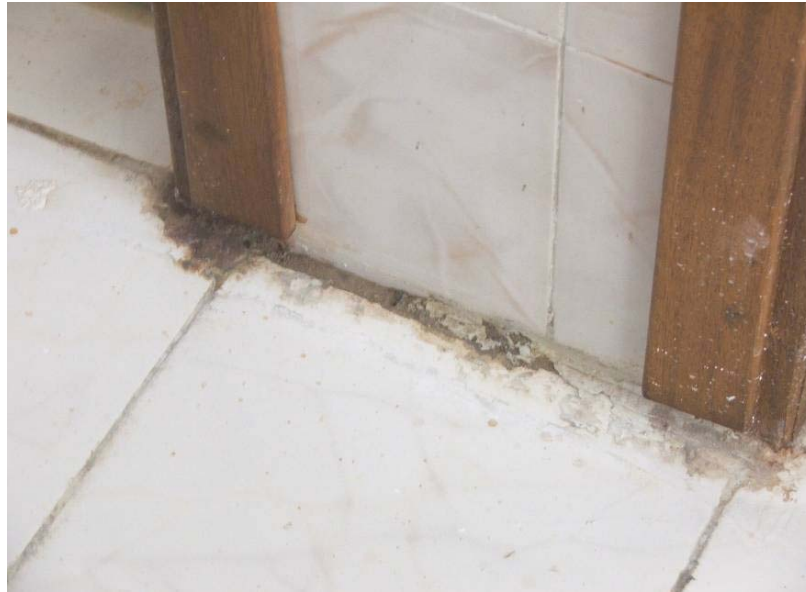
In addition to the doors, we found the floor tile in many areas needed cleaning. According to the USACE PE, this had been a continual problem and it had been

listed as a deficiency on the USACE Quality Assurance Representative's deficiency tracking log. Additionally, in some areas, particularly near the walls or corners of the showers or water closets, we found the quality of workmanship associated with the ceramic floor tile grouting to be poor. Site Photo 10 provides an example of grouting workmanship, showing excess material left on the floor tile and dirty grout. One factor affecting the quality of workmanship, especially with finish work activities, was the requirement to utilize local labor. The USACE PE informed us that in order to maintain good relations with the local Iraqi leaders, the contractor was compelled to hire local labor, the majority of which were unskilled. The use of unskilled labor on this project directly influenced the quality of workmanship.

Site Photo 10. Dirty and excess grout material left on ceramic tiles

Page 11. In addition to the doors, we found the floor tile in many areas needed cleaning.

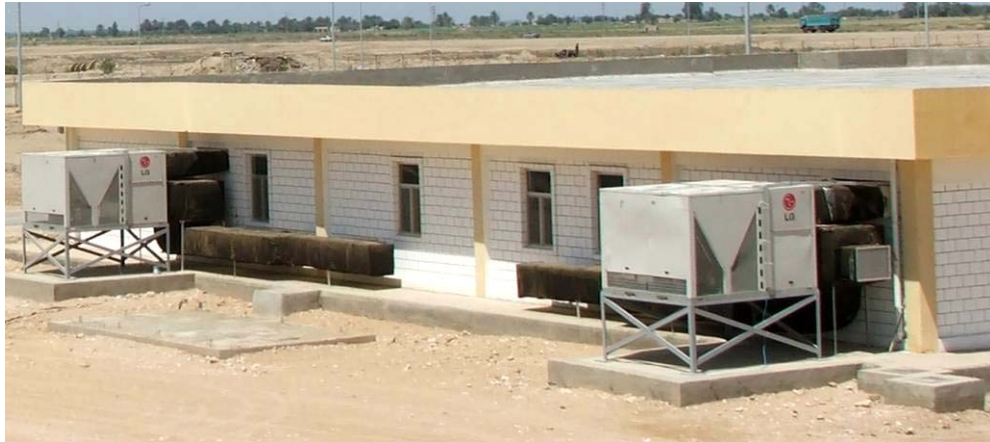
The task order SOW required a kitchen and restaurant building (dining facility) to provide meal service for Iraqi soldiers. The architectural floor plan included a 900 m² facility, consisting of a central kitchen servicing two separate dining rooms, one for the officers and the other for the enlisted soldiers. The mechanical design required the dining rooms to be cooled with two, 20-ton central HVAC units. Site Photo 11 shows an exterior view of the one side of the dining facility, which includes the two central HVAC units. The original design for the kitchen area called for five individual, 2-ton window HVAC units. However, due to budget constraints, the five individual HVAC units were de-scoped from the project.

Site Photo 11. One side of the dining facility with the two central HVAC units

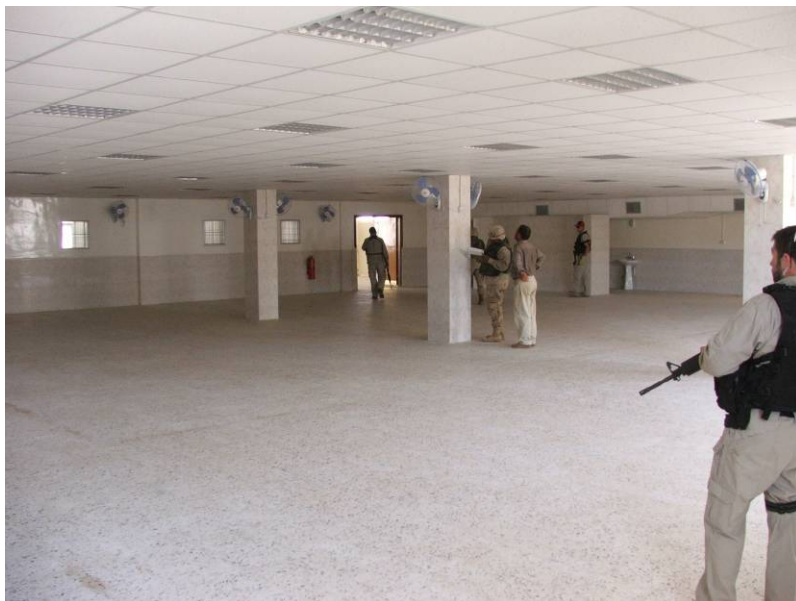
The dining facility interior design included aluminum frame windows, metal exterior doors, and terrazzo tile floors. In the kitchen, the design required glazed ceramic tile on the wall up to the door height. Beyond that height, the wall was to be plastered and painted. In the two dining rooms, the original design required plastered and painted walls and ceiling. Prior to construction, the contractor requested, and received approval to install a suspended acoustical ceiling in the dining areas, which included the recessed fluorescent lights and the diffusers for the HVAC system. In addition, the contractor installed glazed ceramic tile on the lower portion of the walls in the dining rooms and on the columns in the enlisted dining room. Site Photo 12 illustrates the enlisted dining room and its interior finishes including the suspended ceiling, floor tile, and wall coverings. To augment the HVAC system, the contractor installed fans in the dining rooms as required by the design. The contractor also installed in compliance with the design, eight pedestal style washbasins in the enlisted dining room and four in the officer dining room.

Site Photo 12. Enlisted dining area

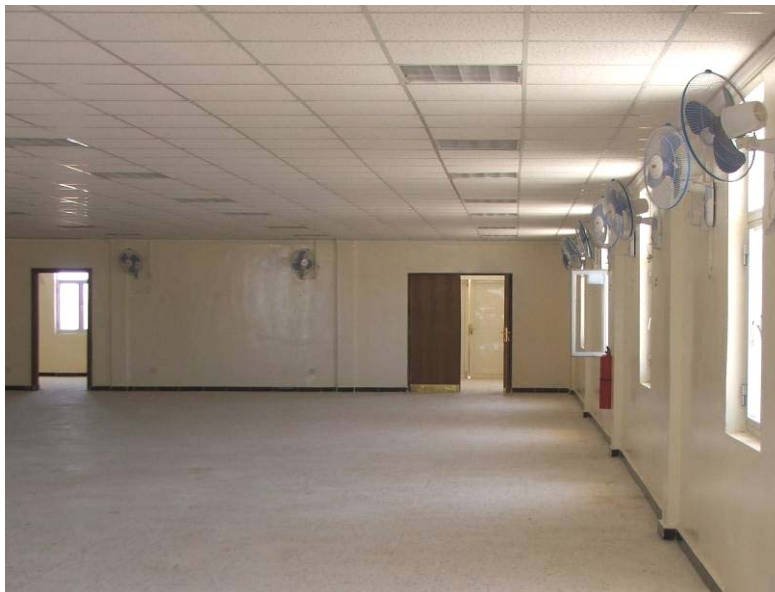
The design for the 11.8 m x 30 m sport room, which included an office and a storeroom, required plastered and painted walls and ceilings, terrazzo floors, aluminum frame windows, wood interior doors, and metal exterior doors. The original design required window air conditioning units, but the air conditioning units were de-scoped from the project prior to construction. Site Photo 14 shows the sport room. In the absence of air conditioning, the contractor had placed fans along the walls. In addition, instead of a plastered and painted ceiling, the contractor installed a suspended acoustical ceiling after requesting and receiving approval from the USACE Area Office. Based on our observations of the sport room construction, the facility as constructed, met the requirements of the design.

Site Photo 14. Sport room with adjoining office and store room

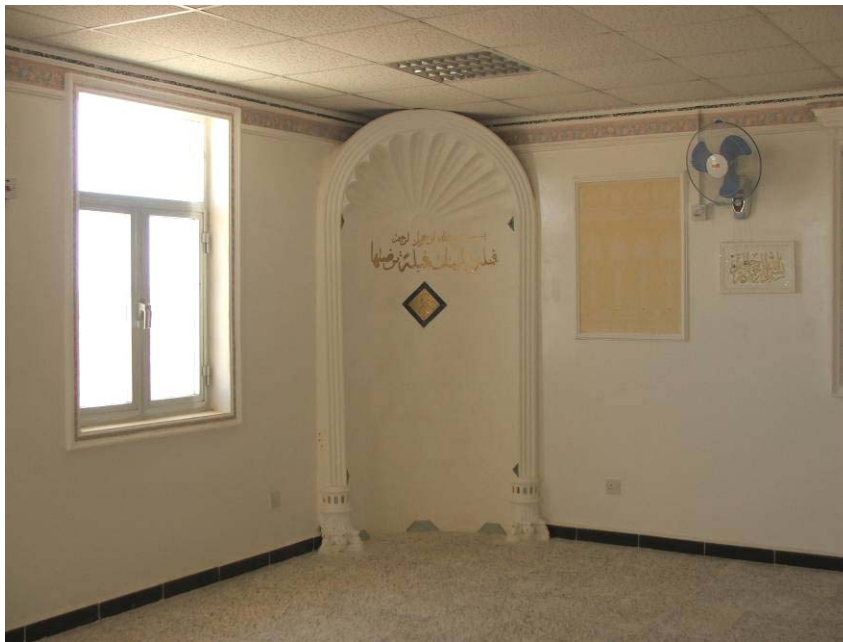
Similar to the sport room, the architectural design for the 10 m x 10 m Mosque included terrazzo-tiled floors, plastered and painted walls, and aluminum frame windows. The contractor installed a suspended acoustical ceiling in lieu of a plastered and painted ceiling. In addition, the original design required window HVAC units, but as mentioned earlier, the contractor substituted split system units after receiving approval from the USACE Area Office. In constructing the Mosque, the contractor included several enhancements. The contractor provided a “mihrab”³ as shown in site Photo 15. In addition, the contractor hung framed inspirational verses from the Koran on the walls, and the contractor installed patterned window and wall coverings.

Site Photo 15. View of the Mihrab in the mosque

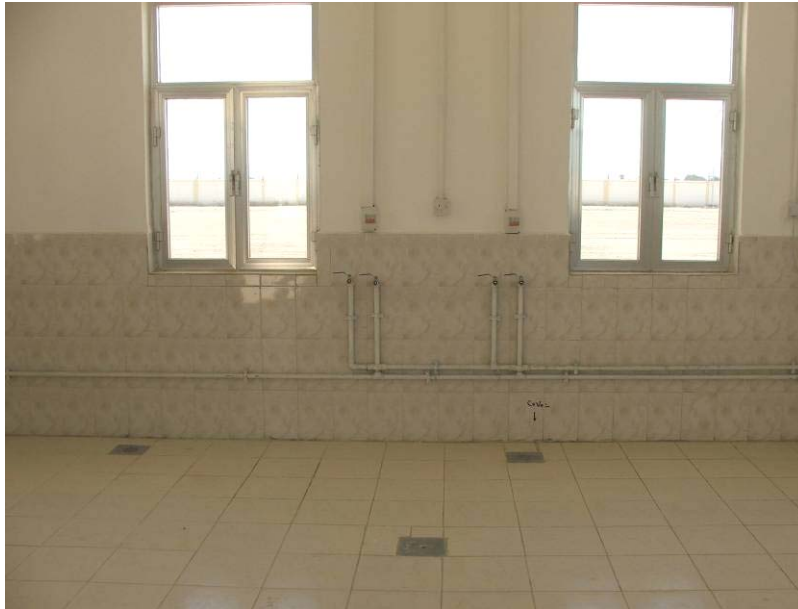
The washers and dryers were not part of the scope of work and were to be provided by the Iraqi military. The laundry's required interior finishes included ceramic tile floors, ceramic tile walls (on the lower half with the upper half plastered and painted), as well as plastered and painted ceilings. Site Photo 16 shows the interior of the laundry, including some of the piping, connections and power outlets for the washers. Our observations indicated the laundry construction satisfied the design requirements.

Site Photo 16. Interior of the officer laundry

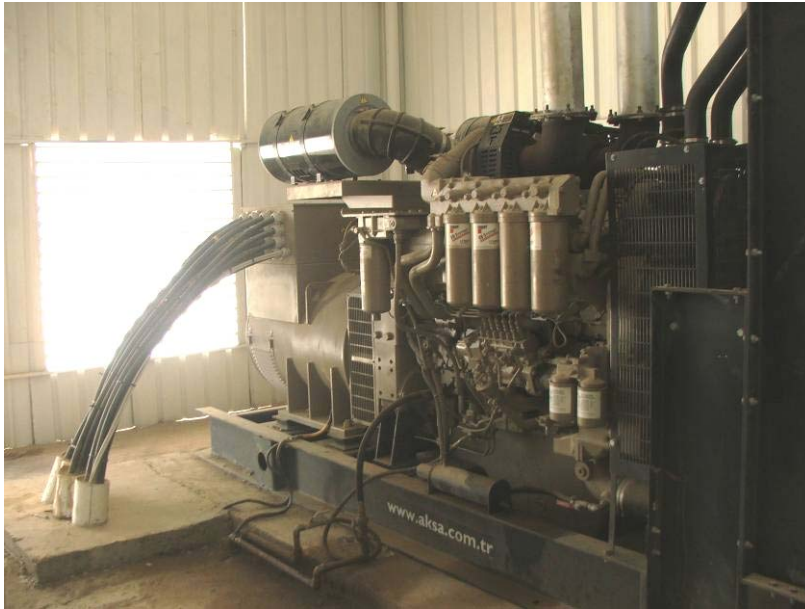
The generators' size and capacity requirements were recalculated after the project started, resulting in smaller generator needs. According to the USACE PE, the requirements changed because Modification 01 de-scoped the classroom and club/theater buildings from the project. In addition, the generator site location was moved from the original remote location to a more central location closer to the garrison's other buildings.⁴

Site Photo 17. One of the two electrical generators installed at the garrison

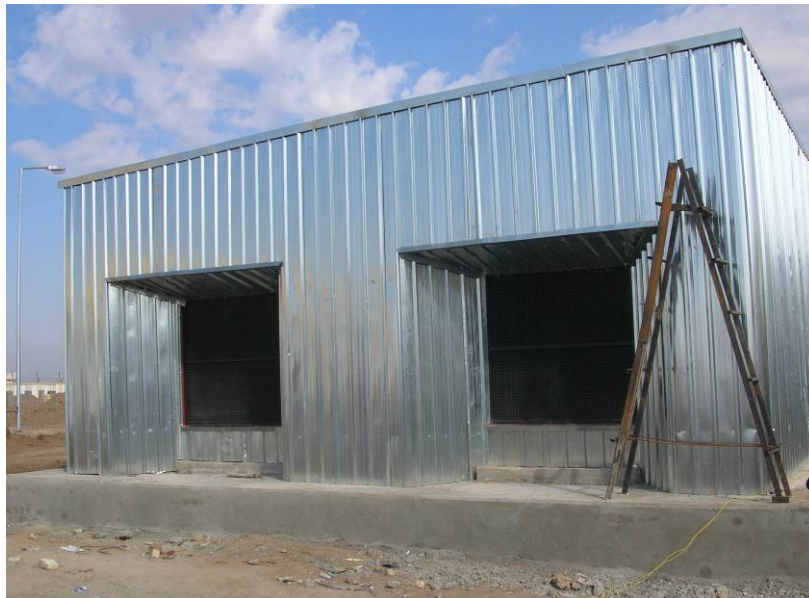
The design required housing the two generators in a reinforced concrete structure with sand lime block-walls similar to the others constructed at the garrison. However, with the shift in site generator locations, a decision was made by USACE to use a pre-engineered metal building to house the generators instead of the reinforced concrete structure. Site Photo 17 provided by USACE, shows the metal building while under construction prior to painting.

Site Photo 18. Generator building while under construction (Photo provided by USACE)

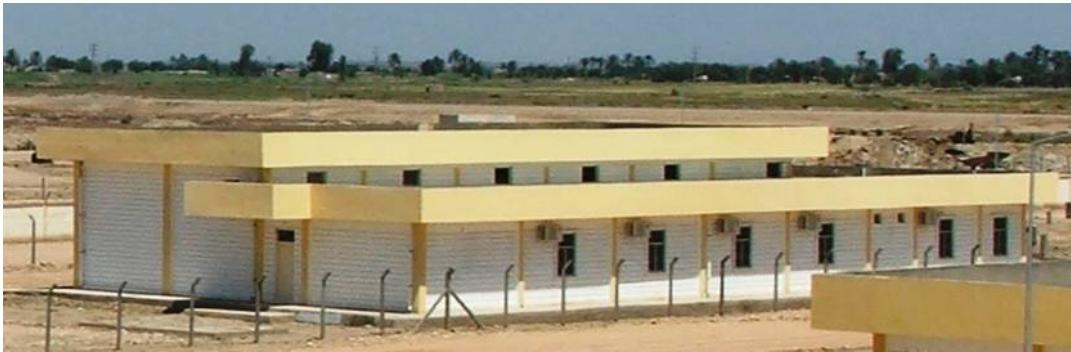
Site Photo 19. Logistics building

We did not find any noticeable deficiencies during our tour of the facility. The construction of the logistics building appeared to meet the requirements of the design.

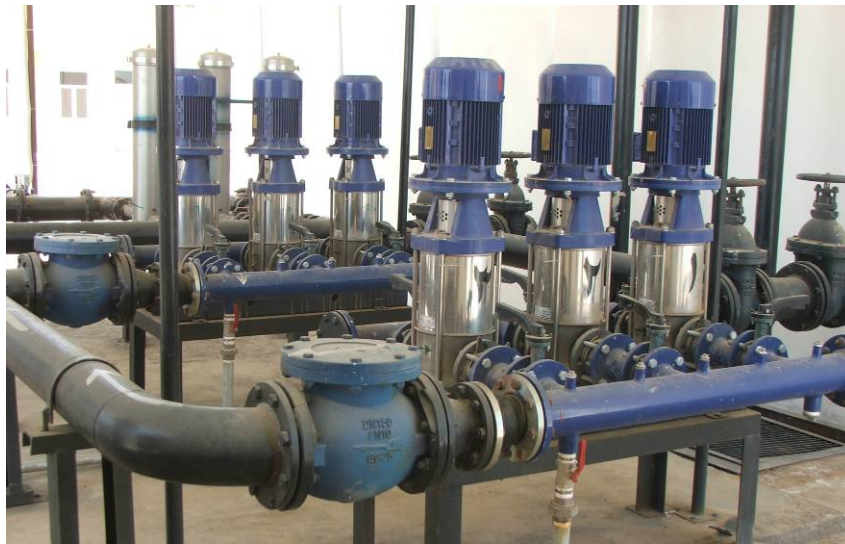
The pumping facility design included two sets of three booster pumps (one set to serve in standby mode). Each pump, rated at 24 cubic meters per hour at 50 m of head, is designed to pump water from the storage tanks to the garrison buildings. The design also included three, 5 micron cartridge filters inside stainless steel housings to filter out sediments prior to the water entering the service line to the garrison buildings. Site photo 20 shows the booster pumps. During the site visit, we did not observe any deficiencies associated with the pumps, filters, piping, and valves, including any evidence of leaks or loose connections.

Site Photo 20. Two sets of booster pumps, and cartridge filters are in the background

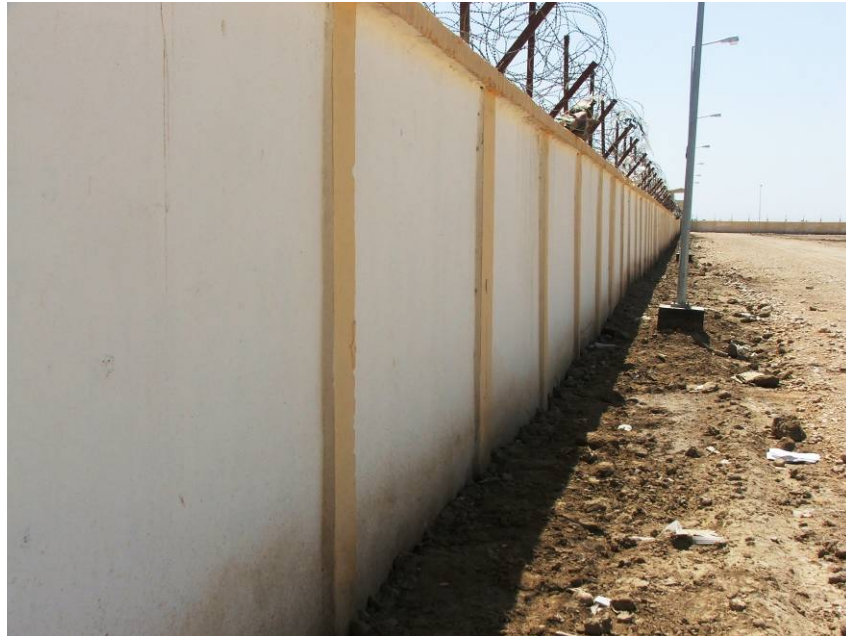
Site Photo 21. One section of the perimeter wall

The design required a 2.5 m high block wall capped with a concrete coping, with three strands of rolled barbed wire on top of the wall. The foundation support for the perimeter wall included reinforced concrete footers to support the columns and a reinforced concrete tie beam under the wall between the columns. According to the architectural plans, at every 2.5 m, a supporting column was required along the wall with expansion joints required every 10 m. However, in the structural plans, a supporting column was required every 3 m and expansion joints every 12 m. Based on our observations, it appeared the contractor followed the spacing requirements from the structural plans. Further, we did not see any evidence of cracking or other noticeable defects along the portion of the south wall that we inspected. The construction of the wall in this section exhibited good quality workmanship.
